Fiber Reinforced Structures for Small Turbine Engine Fragment Containment (Phase II)

July 1996

Final Report

6. Performing Organization Code	
7. Author(s)		8. Performing Organization Report No.	
9. Performing Organization Name and Address Pepin Associates, Inc. 15 Holly Street Scarborough, ME 04074		10. Work Unit No. (TRAIS)

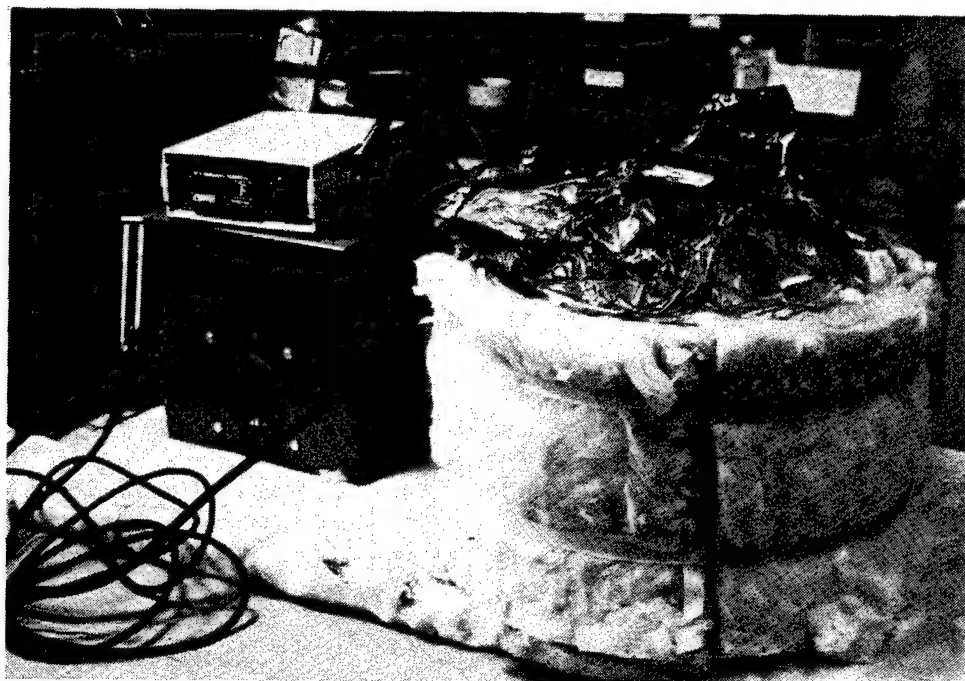
FIGURE 37. PHOTO AFTER MOLDING CYCLE SHOWING VACUUM BAG AND INSULATION. TOP AND ID INSULATION HAVE BEEN REMOVED.

The ring structures were fabricated by wrapping a 9-inch-wide Kevlar fabric onto a drum until the required number of plies was achieved. Splices were overlapped and sewn. A Teflon film was taped to the ring surfaces and the ring edges sewn with Kevlar or dacron to hold the dry ring laminate together while the 12K towpreg was inserted. The needle guides were similar to those shown in figure 33 except narrower so the ring could fit into them. A completely sewn ring is shown in a partially assembled molding tooling in figure 35. The ring is shown inside a steel ring tool wrapped with a silicone heater. Steel plate arc segments were placed against the inner diameter (ID) wall of the ring and held in place with ties. The entire assembly, shown in figure 36, was wrapped in a breather ply and then a vacuum bag. The vacuum forced the ID segments radially outward to mold the ring against the ID of the steel ring tool. Figure 37 was taken just after molding and shows the bag and outside thermal insulation.

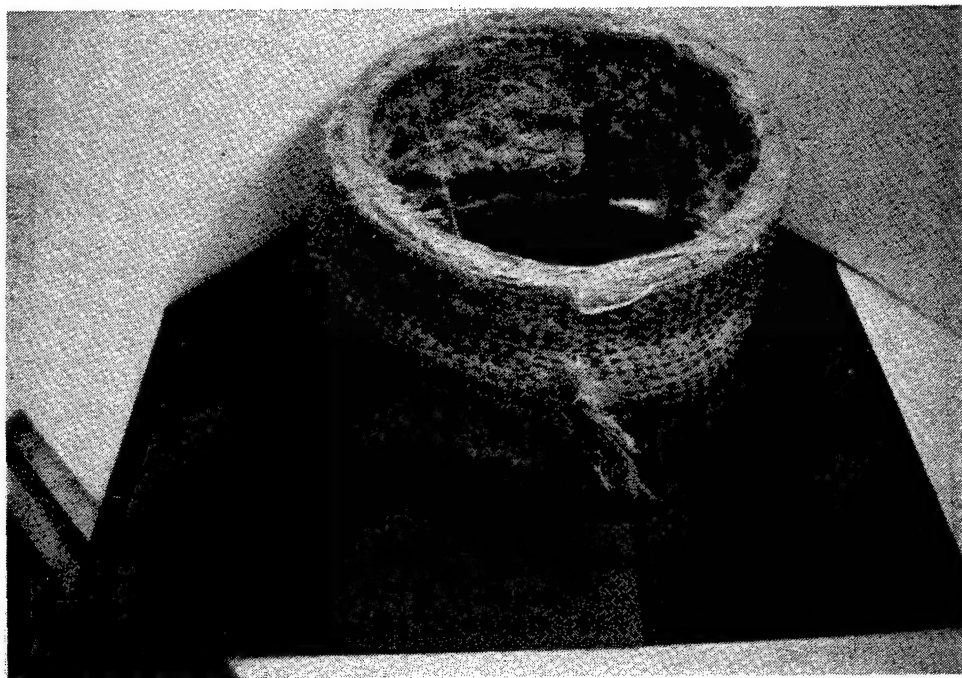
FIGURE 52. POSTTEST PHOTO OF SPIN TEST STRUCTURE 5 SHOWING BLADE EXIT POINT. DISK FRAGMENTS WERE STUCK IN THE RING AFTER THE TEST

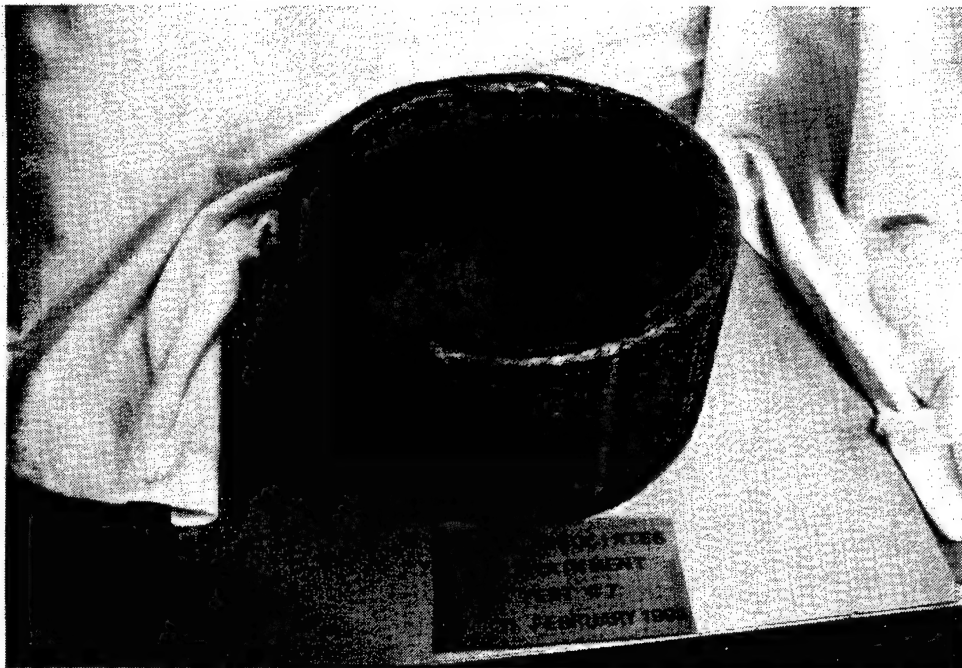
FIGURE 55. SPIN TEST STRUCTURE 7

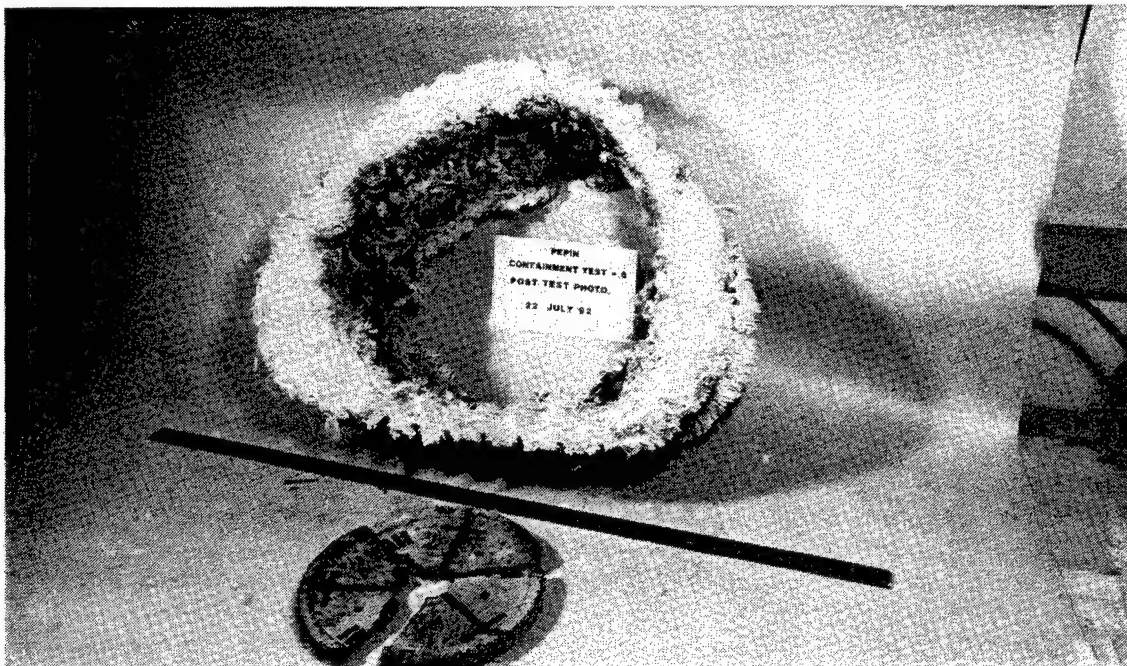
FIGURE 62. CONTAINMENT STRUCTURE 9 AFTER TESTING. ROTOR ENERGY WAS 1.39 MILLION IN-LBS. DISK FRAGMENTS DID NOT PENETRATE ALTHOUGH ONE SEEMS TO HAVE TUMBLED OVER THE EDGE AT A LOW ENERGY LEVEL

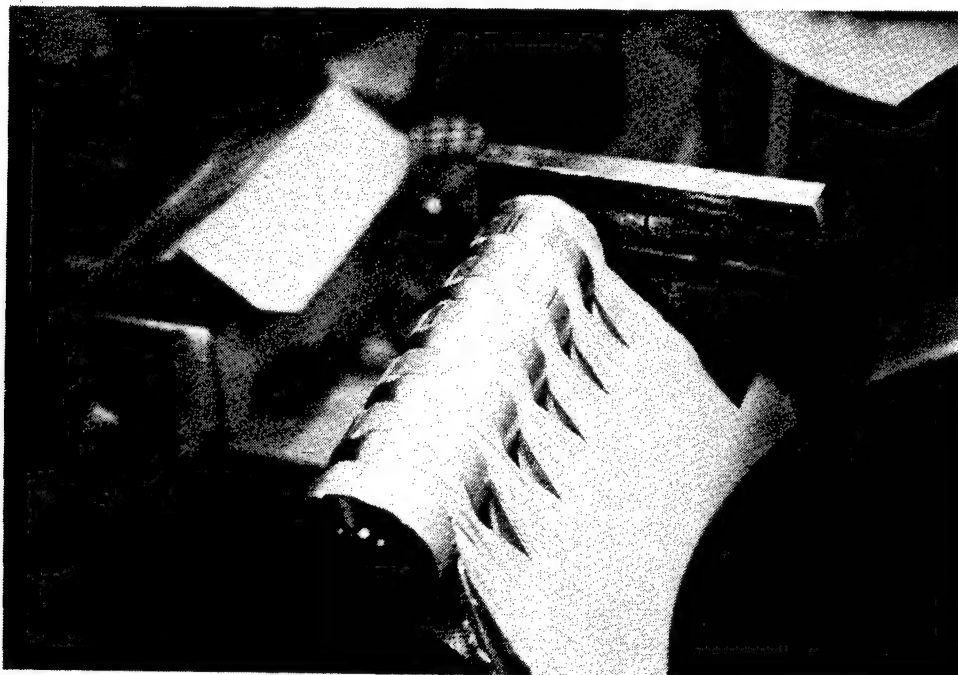
FIGURE 65. CLOSE-UP OF JOINT AREA OF PANEL AS IT IS FABRICATED. HOLLOW, THIN-WALLED DOUGHNUTS DEFINE THE SPACE FOR THE WARP YARNS TO BE WRAPPED. SOLID DOUGHNUTS ARE SPACERS FOR THE SLOTS INTO WHICH THE OTHER PANEL'S YARNS WILL FIT.

The tenth spin test structure was composed of two curved panels joined by hinge type joints. The potential advantage of these joints is that they would be lighter and allow motion of a panel around a hinge as for a cowling for example. Forty-three plies of Kevlar style 745 fabric formed the energy absorbing component of each panel and the panels were sewn with the candidate B architecture graphite/epoxy towpreg as was ring number 7. The fabric was all oriented in the $0^{\circ}, 90^{\circ}$ direction so the basic configuration of the structure is the same as for ring 7. The two joints, one at each end of this lenticular shaped structure, were formed by wrapping the 9-inch (22.9-cm)-wide fabric around two rods as shown in figures 64 and 65. Alternating solid and hollow aluminum doughnuts were slipped over the rod and the fill fibers of the fabric were pulled out only in the joint area leaving the warp fibers to wrap into the open or hollow spaces. The metal ring shown provided the tension as the panel was wrapped. After the panel was wrapped, the warp fibers which were wound into the thin walled open doughnuts were stitched a few times to trap the open doughnuts into the part. The only function of the thin-walled doughnuts was to contain the warp fibers as they made their continuous turn around the joint. The part was then removed from the tooling by sliding it off the solid rod. At this time the solid doughnuts, which merely act as spacers, were removed as well. The spaces which the solid doughnuts occupied accommodate the wound joint section of the opposing panel. The hinge type joint, then, was formed by continuous, unidirectional warp yarns of the fabric making a racetrack-like turn around a pin. The pins for both joints were fabricated by pulling dry Kevlar 29 tows into a thin-walled aluminum tube. The actual tubes had 0.037-inch (0.094-cm) wall thickness and each contained 2079 Kevlar 29 tows of 3000 denier each. The panels were stitched and molded as before and the finished structure is shown in figure 66. The weight of the completed structure was 22.88 lb (101.8 N) and its dimensions are given in figure 32.

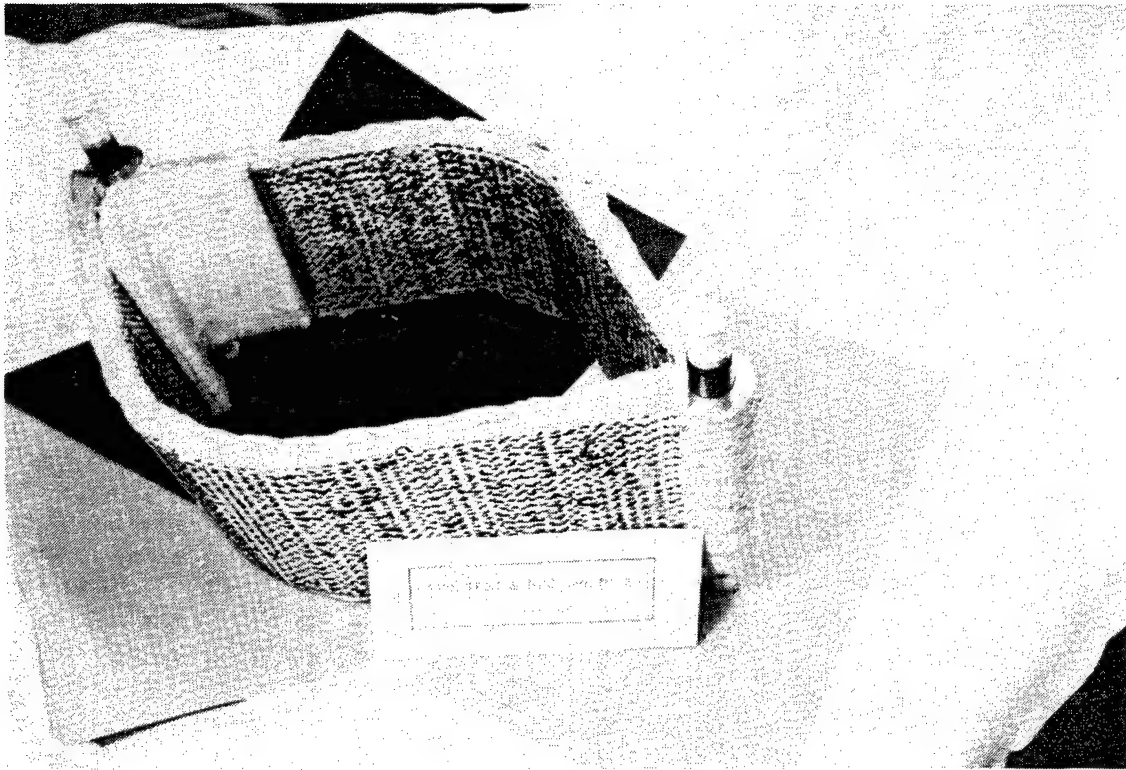
FIGURE 66. FINISHED AND ASSEMBLED SPIN TEST STRUCTURE 10. PINS AT THE JOINTS ARE UNIDIRECTIONAL KEVLAR IN A THIN THIN-WALLED, 1.25-IN OD ALUMINUM TUBE. THE JOINT PROTECTIVE SHIELD IS A 30-PLY DRY LAMINATE ATTACHED WITH VELCRO®.
